# Surface inspection of hot rolled seamless tubes

During hot rolling of laminated seamless tubes, surface marks and other defects may occur sporadically due to wear of the roll stands. This article describes a new automatic inspection technology for surface defects developed for a seamless tube manufacturer in Spain. The automated inspection system is installed at the exit of the push bench, just where the defects originate. Under harsh environmental conditions due to dirt, vapour and high temperatures, the system must be capable of inspecting the whole surface of the tubes in real time. An intelligent classification software tool based on a support vector machine is used to recognize the previously learned defects.

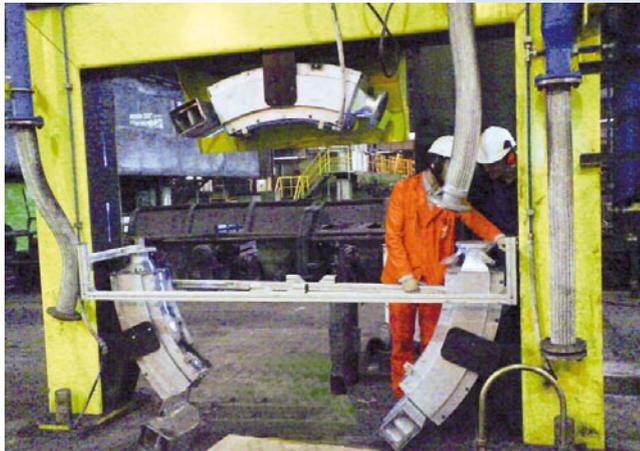
**Figure 2.**  
The bridge frame carries three enclosures

A bridge frame carries the three enclosures, located at approximately 120 degrees to one another (figure 2). The distance between the tube and the enclosures is about one meter.
